Repair of Shell tank by laminating with LEYCO-POX 171 S resins (case histories)

LEYCO-POX 171 S Technical Manual

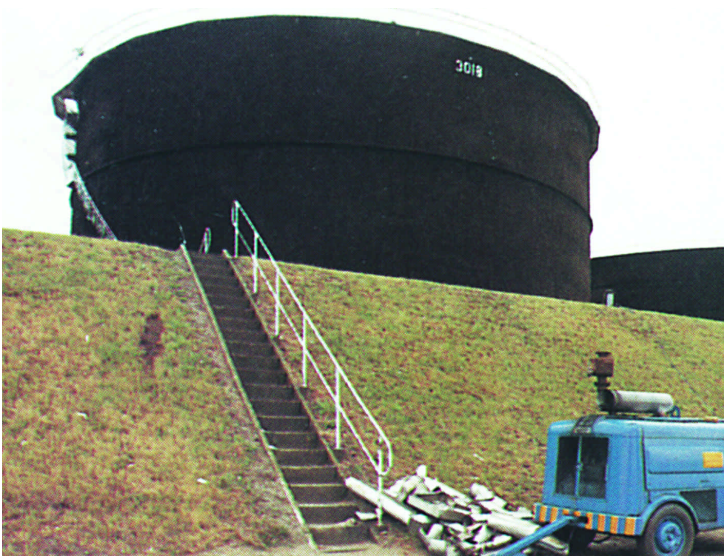
External view of tank

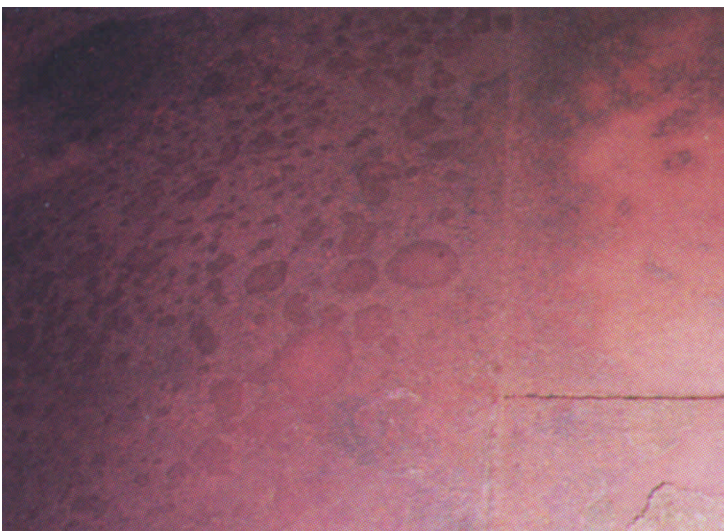
Close-up view of repair of corroded tank bottom

Tank No. 3018 on Europort storage site in the Netherlands has been in service for 20 years, for most of that time storing corrosive condensate liquids, essentially crude oils containing high proportions of salt water. During 1979/80 it became apparent that a major repair operation for the tank bottom was necessary.

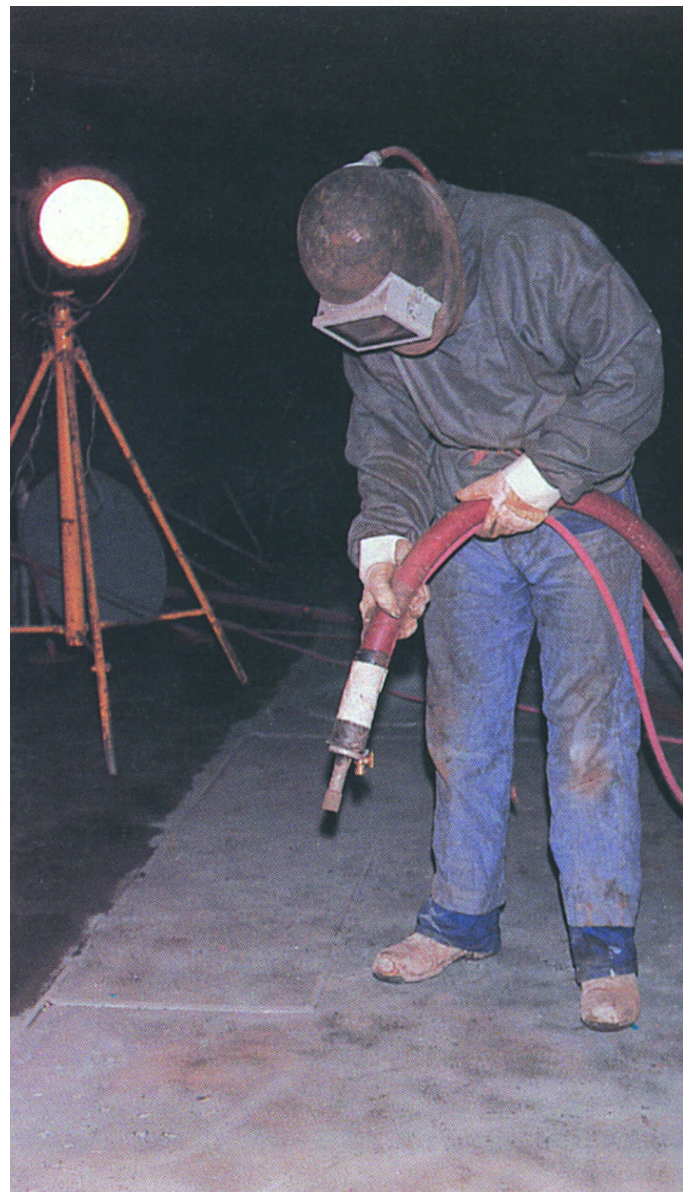
Grit blasting

- The entire tank bottom and the walls to a height of approximately 1 metre were grit blasted to Swedish standard SA 2 1/2
- Immediately after blasting an iron oxide pigmented LEYCO-POX 171S resin (solvent-borne) primer was applied and allowed to cure.

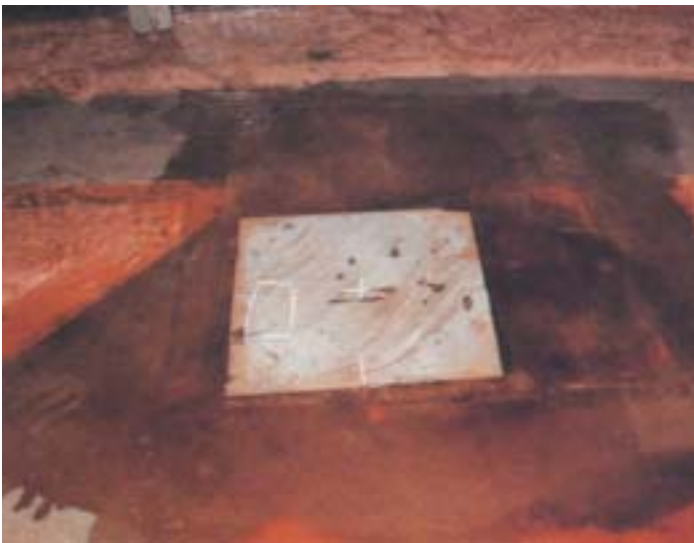
Through hole covered by bonded steel plate

- Through holes in the steelplate were covered by bonding on small pieces of new steelplate, using the laminating binder described below as the adhesive.

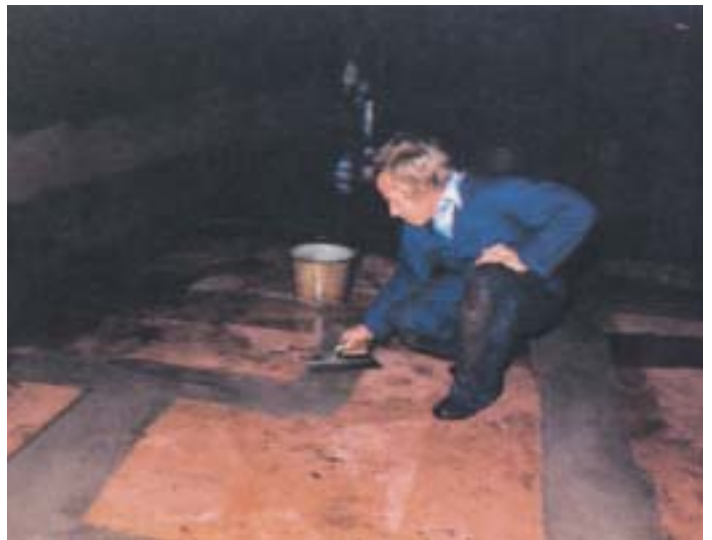
Smoothing irregularities with LEYCO-POX 171S mortar

- Hollows (as opposed to holes), weld lines and any irregular steps caused by bonding steelplate over holes were then covered with an LEYCO-POX 171S resin mortar (sand filled) so that a continuous smooth surface was obtained over the entire tank bottom. It is essential that any abrupt irregularities in the surface are removed before laminating.

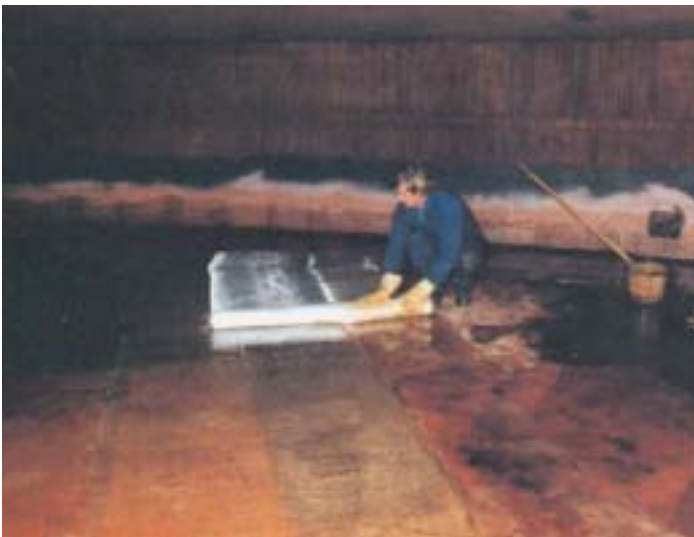
Rolling out glass cloth

- The LEYCO-POX 171S laminate was then applied. This was carried out by spreading the LEYCO-POX 171S resin binder on to the surface immediately followed by a layer of woven glass cloth (approximate weight 500g per square metre) which was then rolled (with a split washer roller) to remove entrapped air and to ensure good wetting of the glass. A second layer of resin binder was then applied followed by a second layer of glass cloth, care being taken to overlap half of the second glass layer on to the first layer, again with rolling. The laminate was allowed to harden (3 days) after which the final application of resin binder and one layer of glass surfacing tissue was made.

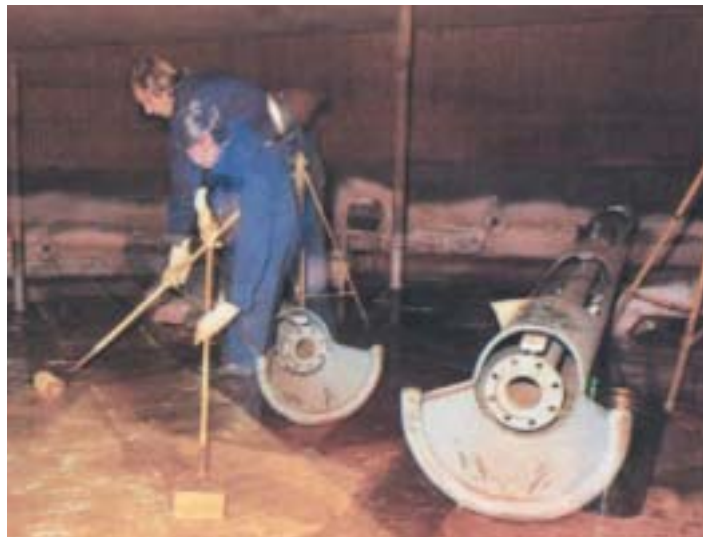
Spreading LEYCO-POX 171S resin binder

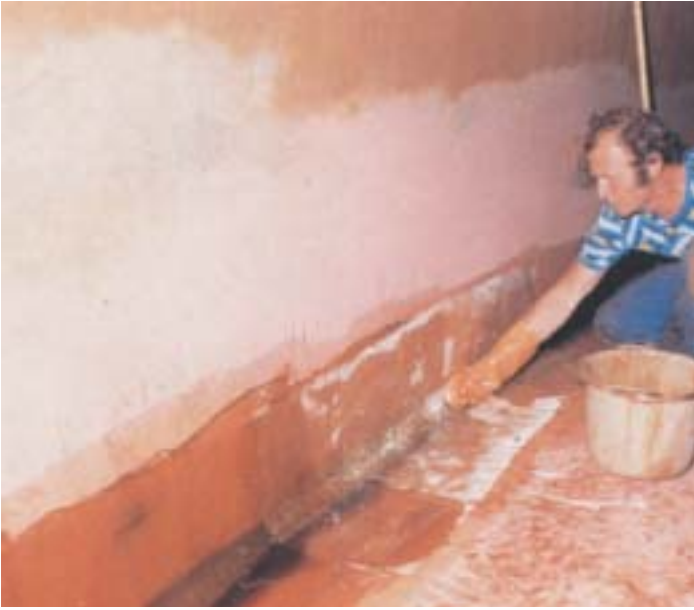
Applying laminate to edge of bottom/wall corner

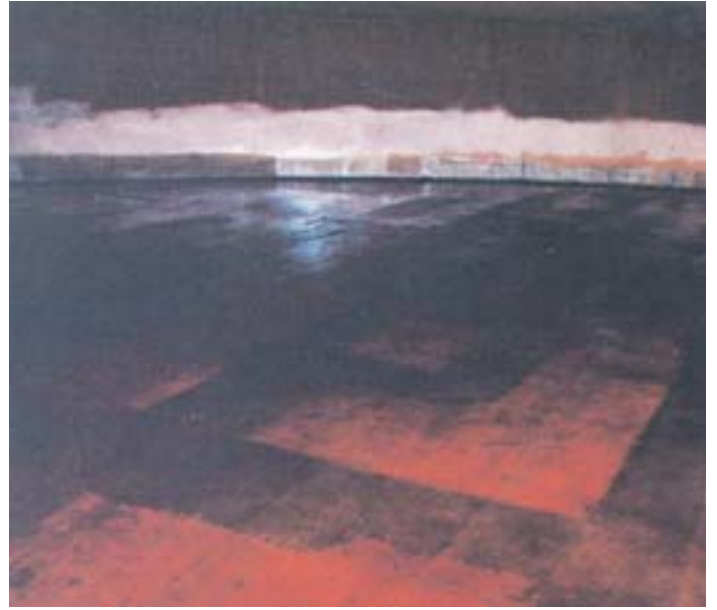
View of repaired tank bottom

The total laminate thickness after cure was 3-4 mm. The cost of repair was less than the estimated costs of lifting, re-bottoming with steel and external protection (by painting) of a new steel bottom.
